Norah Head Lighthouse Land Manager Board

May 2020 Newsletter

The Waterproofing Membrane On The Gallery Level

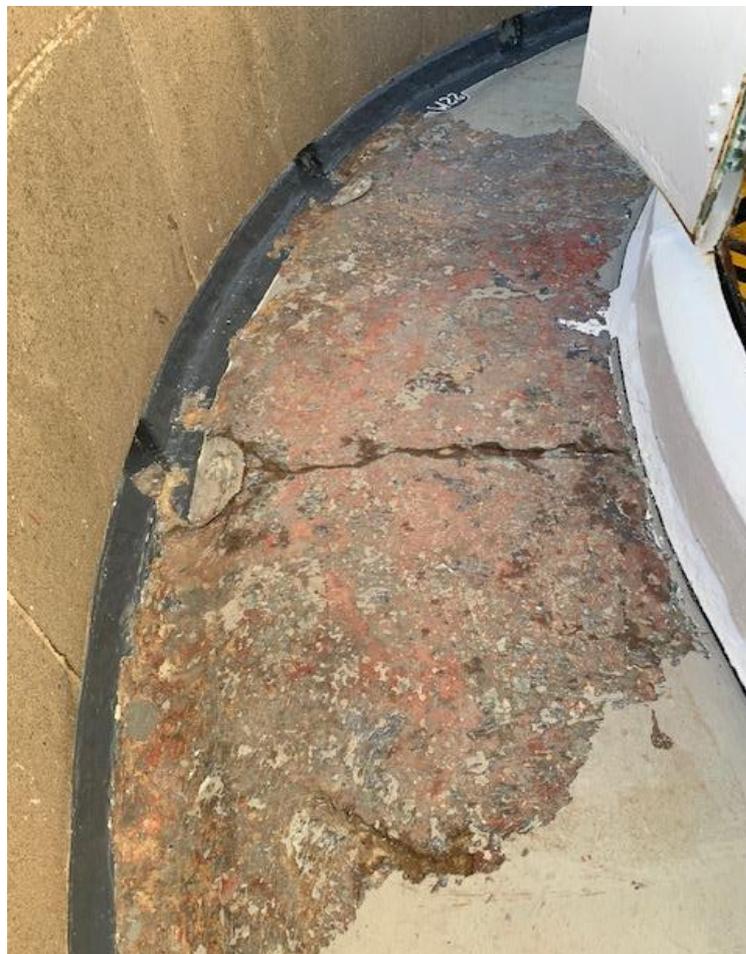
The picture below shows why. There was quite poor adhesion and his plan involved removing bulk of old coatings, repairing joints and cracks.

Mark reported that the bulk of his work on the gallery was on his bum, with regular stretches and chin ups taken. He attempted to keep it simple and uncomplicated, but it still required a fair amount of amount of labour. He wore his general-purpose zoot suit, with full face mask due to dust and other contaminants. His method was to go digging, inspect and plan from there. He removed old coating by chipping hammer, blade scrapper, wire wheel then jet blast.

Once fully prepped he would diamond cut out the old joints and tuck point new mix in (traditional) The gallery now has had 4 coats 2 pac, been stripped back, old joints cut out and new pointing applied, painted, sanded ,painted. A water proof membrane tape applied over the joints again to insure they will not weep water for many years! There had been moisture penetrating these joints, today Mark guarantees the area is water tight.

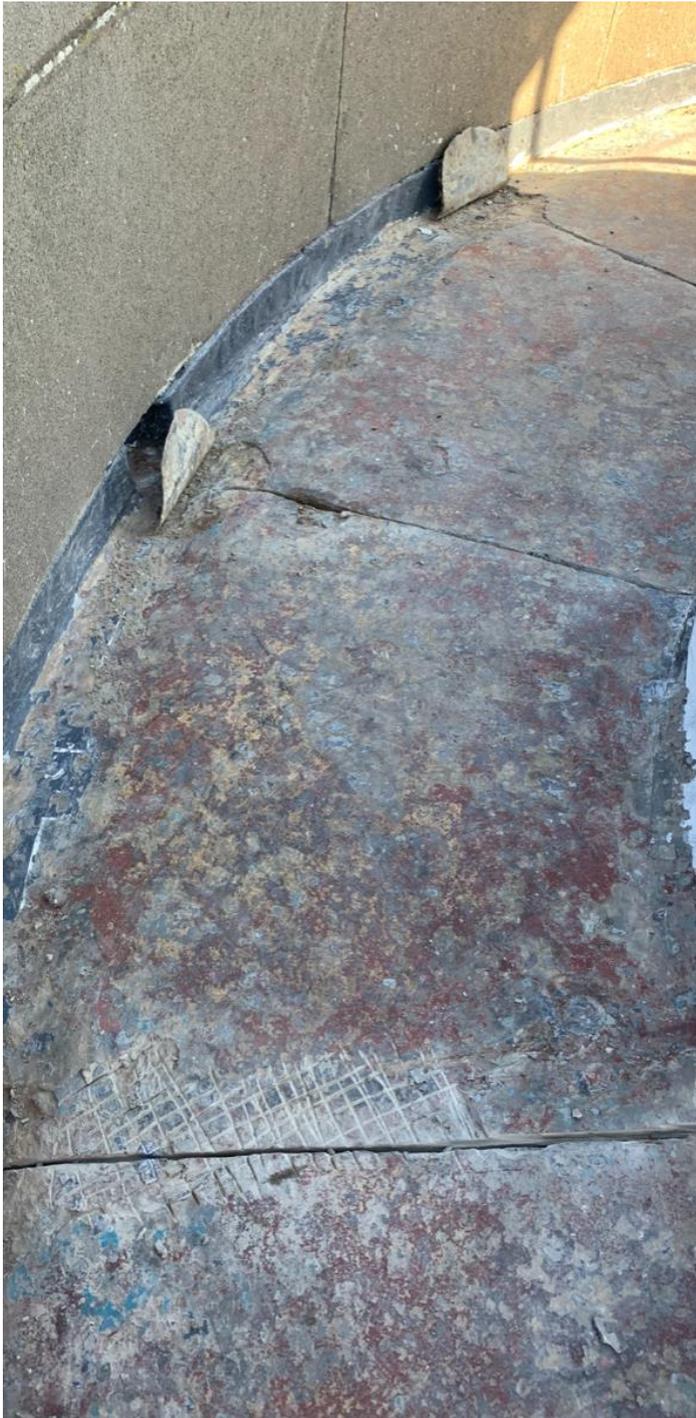
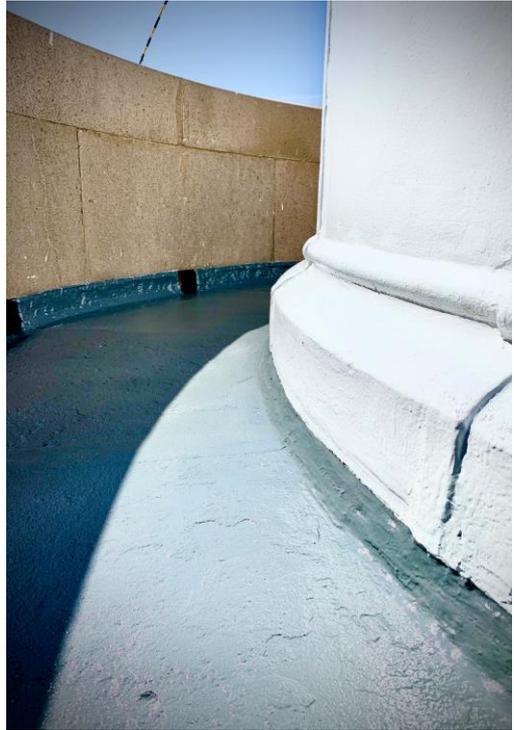
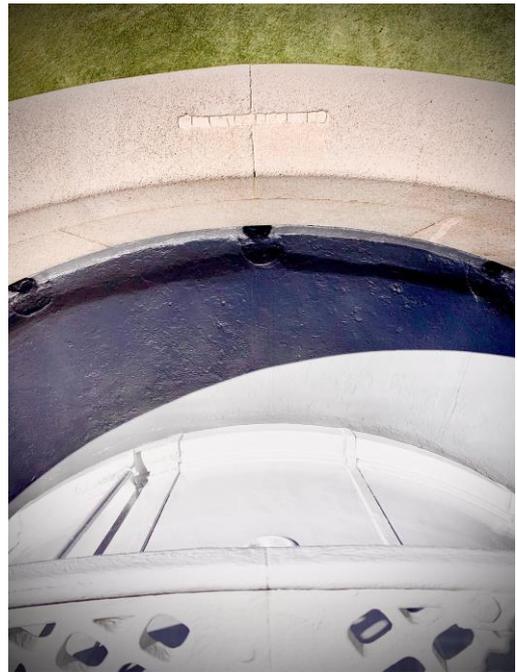
The photo on the left shows the Lantern gallery's 16 segments and diamond cut out the old joints. The photos on the right are of the completed work

The cracks were filled with a Xypex product, a unique chemical treatment for the waterproofing, protection and repair of concrete. The Dulux 2 pac system topcoat was used for the gallery level waterproofing. Access of public to this area required an additive poured in the paint to provide an anti-slip surface to the finish.

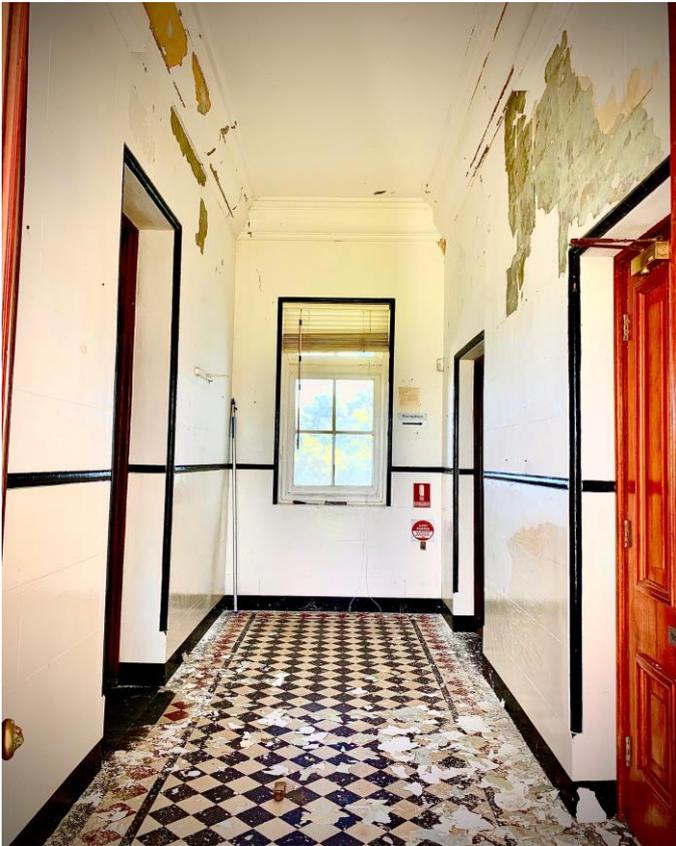
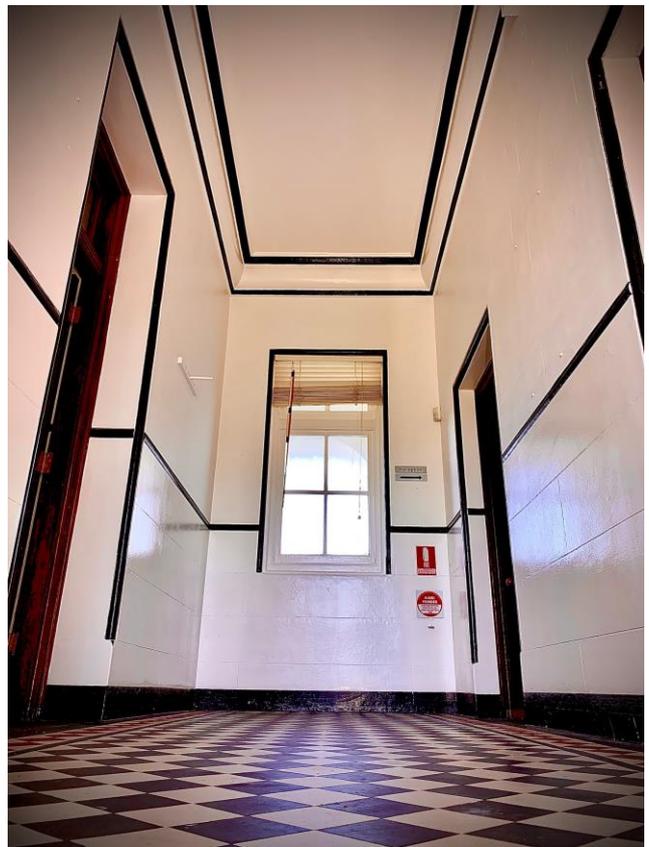
Repainting the tower's entry foyer.

I reported in the December 2019 Newsletter that the Department of Industry had repaired the parapet level of the lighthouse and that when the parapet was stripped back to the concrete slab that was laid in 1903, revealing that there were large cracks in the concrete that made it leak like a sieve. Then we had heavy rain while the work was going on and the entry foyer and rooms below were flooded. The water damaged the paintwork and Mark Sheriff took the opportunity of being on site to remove flaking paint and repaint it.

Marks original plan was to do a touch up but have decided to give it his best due to it being the grand entrance it is. Sections had some failing adhesion with moisture underneath so a dehumidifier was run overnight in the space. The work involved using a blade scraper, a wash down, applying an oil-based binder sealer, then enamel applied under dado line and washable interior acrylic above the black line.

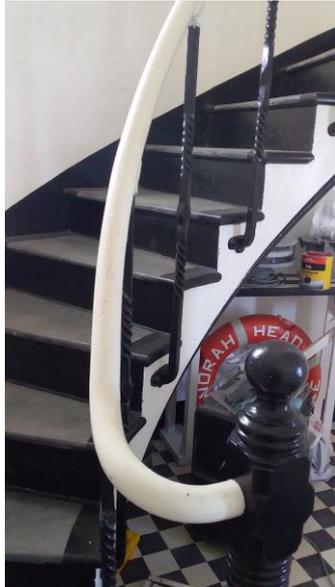
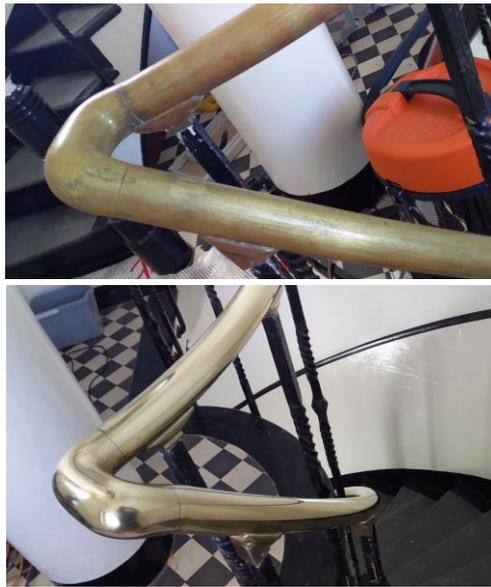
Stairs Handrail

Board Secretary and Tour Guide David Irving used the shutdown to remove the paint from the stair's handrail. He has done grand, sterling job on the brass handrail, it's very impressive.

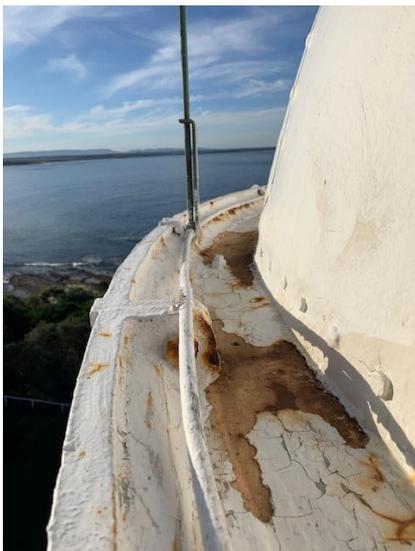
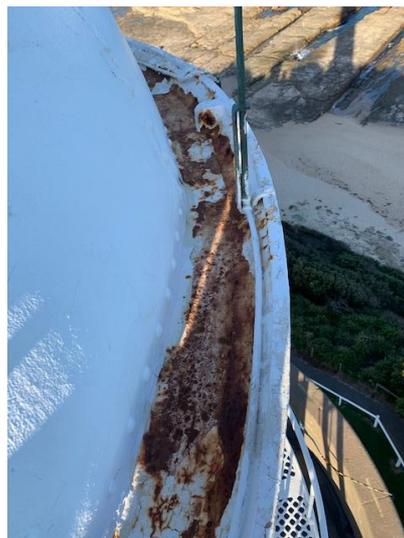
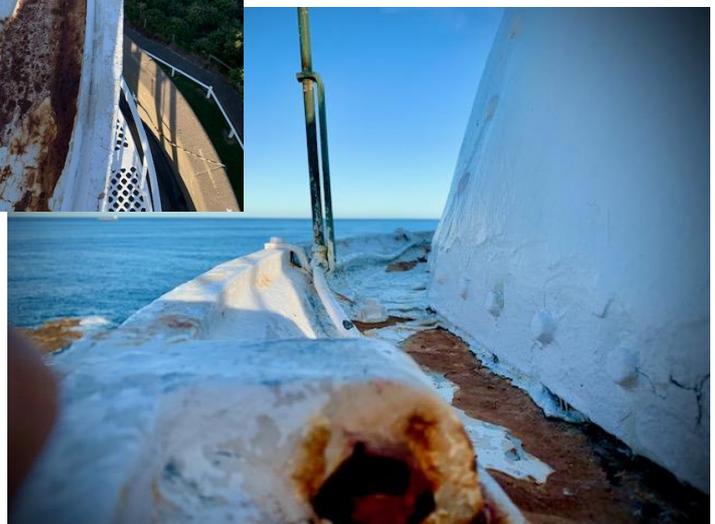
Dome Gutter also needs attention

The photos below show the dome gutter that will be one of the items repaired in the coming months. The dome also shall have a new paint system applied and the wind vane serviced.
