Norah Head Lighthouse Land Manager Board

May 2020 Newsletter

The Waterproofing Membrane On The Gallery Level

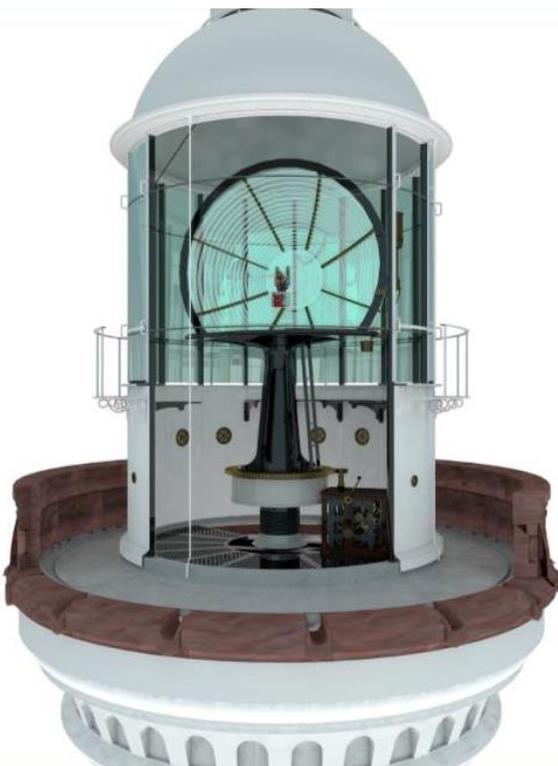
The waterproofing membrane on the gallery level of the lighthouse had failed allowing water penetration into the tower. Mark Sheriff provided the Board with a quotation for repairs and fortunately the NHLRLM Board was successful in obtaining a Heritage Grant to undertake repair from the Central Coast Council.

All buildings expand and contract with changes in temperature. In buildings made of brick or block where no allowance is made for this, i.e. a contraction/construction joint. With its high level of exposure these cracks would allow the penetration of water into the blockwork thus making the building damp. If exposed to continuous damp the long term the possibility of the blocks softening and eroding and failing structurally.

The Norah Head Lighthouse gallery level has often provided issues of water ingress. The coating breaks down with wear and tear, along with trip hazards for the visiting public. The experience is that there is no product available which can appear to last over ten years, which requires to removing a build-up of the old existing coatings and starting again!

Once fully prepped he would diamond cut out the old joints and tuck point new mix in (traditional) The gallery now has had 4 coats 2 pac, been stripped back, old joints cut out and new pointing applied, painted, sanded ,painted. A water proof membrane tape applied over the joints again to insure they will not weep water for many years! There had been moisture penetrating these joints, today Mark guarantees the area is water tight.

The cracks were filled with a Xypex product, a unique chemical treatment for the waterproofing, protection and repair of concrete. The Dulux 2 pac system topcoat was used for the gallery level waterproofing. Access of public to this area required an additive poured in the paint to provide an anti-slip surface to the finish.
